Burlington®

Flush Valve Installation And Problem Solving

Flush Lever Installation

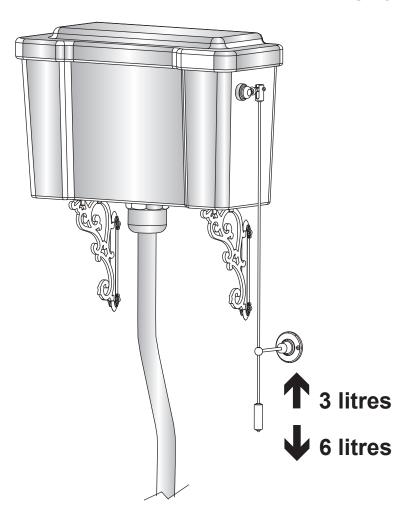
On the High Level WC you must lightly pull the rod down for the 6 litre flush and lightly push the rod up for the 3 litre flush

Please note that it is imperative that there are no loops or kinks in the yellow tube when installed and that the lever is not operated with excessive force as this will damage the cable inside the tube that lifts and lowers the flush valve causing the flush to fail beyond repair

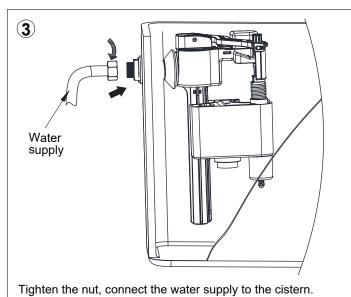
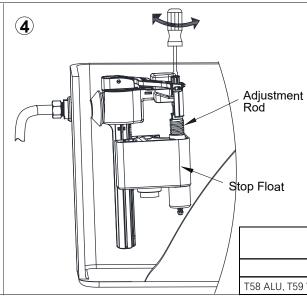
Adjustment the rod:

- A: By adjusting clockwise the water level rises and flush volume increases.
- B: By adjusting anti-clockwise the water level falls and the flush volume decreases.

Item	L (mm) 6L full flush / 3L half flush	L (mm) 4.5L full flush / 2.6L half flush
C5	38	41
T58 ALU, T59 WHI, T60 BLA, T70 CHR	68	78

Problem	Reason	Solution
Incorrect water level	Incorrect adjustment.	Adjust the Water level correctly as per diagram above.
	Water supply is closed.	Open the water supply
Inlet Valve does not work	The filter is blocked.	Clean the filter.
	The Stop Float has been over adjusted beyond its operational range.	Adjust the adjustment rod.
Leakage The Inlet Valve fixing nut has not been tightened.		Tighten the nut.

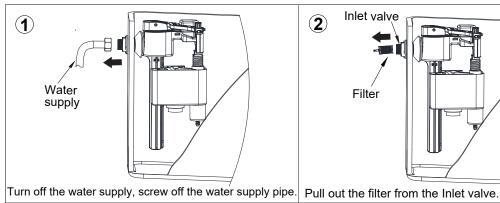
2: Filter cleaning (Please clean periodically)

Clean by rinsing the filter.

Reinstall the filter and the water supply pipe.

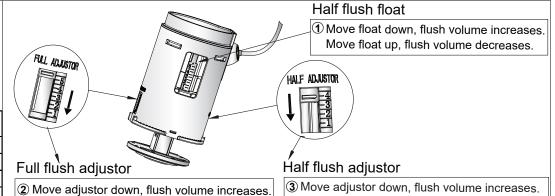
1: Flush Valve scale and adjustment setting

Note: The below diagram is for reference only. In this sample, ①is set to 2.5, ②is set to 5, ③is set to 1.5 The flush valve can be adjusted to suit the paticular cistern, please refer to below tables for the settings.

Item			6L full flush / 3L half flush	4.5L full flush / 2.6L half flush
C5	1	Half Flush Float	2.5	4.5
	2	Half Flush Adjustor	5	5
	3	Full Flush Adjustor	1.5	6
T58 ALU	1 11011110	Half Flush Float	3	5
T59 WHI T60 BLA T70 CHR	2	Half Flush Adjustor	5	5
	3	Full Flush Adjustor	2.5	6

Move float up, flush volume decreases.

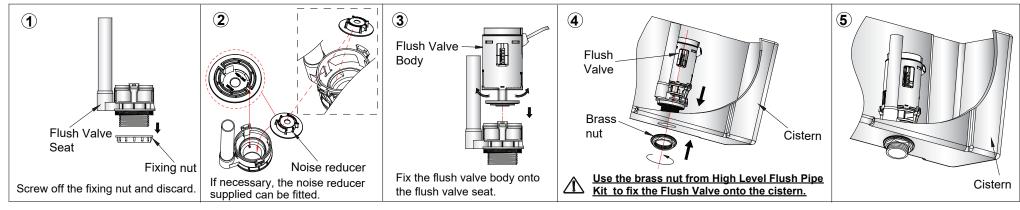
2: Flush Valve installation

Move float up, flush volume decreases.

Problem	Reason	Solution	
Leakage	1.Incorrect installation.2.Flush valve seat does not fit flush valve body.3.Flush valve body is stuck.	1.Install again according to the correct installation procedure. 2.Install again. 3.Disconnet and wash flush valve body.	
No flush, low flush or half flush volume	Cable is distorted.	Remove kinks or sharp bends in the cable.	
Half flush water level is too high or too low.	Water level is adjusted incorrectly.	Adjust water level.
